DEPARTMENT OF TRANSPORTATION

Quality Assurance and Source Inspection

Contract #: 04-0120F4Cty: SF/ALA Rte: 80 PM: 13.2/13.9File #: 99.28**WELDING INSPECTION REPORT****Resident Engineer:**Pursell, Gary**Address:** 333 Burma Road**City:** Oakland, CA 94607**Report No:** WIR-012360**Date Inspected:** 08-Feb-2010**Project Name:** SAS Superstructure**OSM Arrival Time:** 645**Prime Contractor:** American Bridge/Fluor Enterprises, a JV**OSM Departure Time:** 1845**Contractor:** Zhenhua Port Machinery Company, Ltd (ZPMC) Chanxing Island**Location:** Shanghai, China

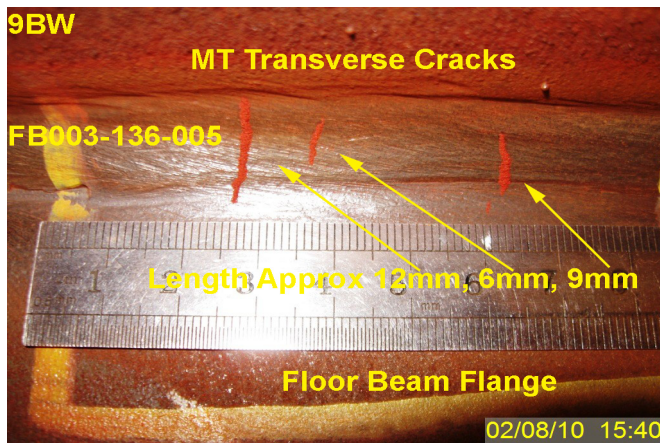
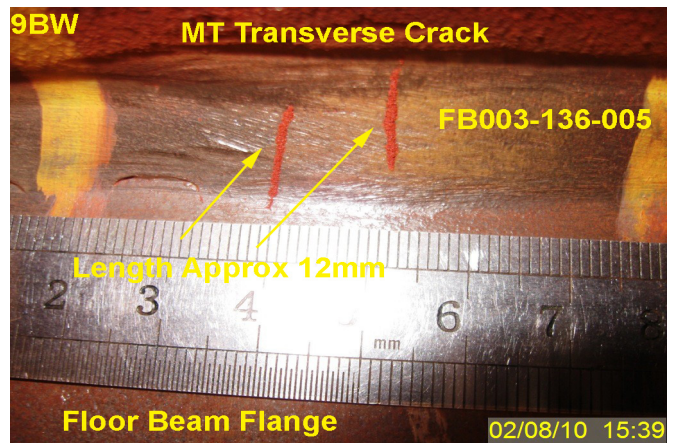
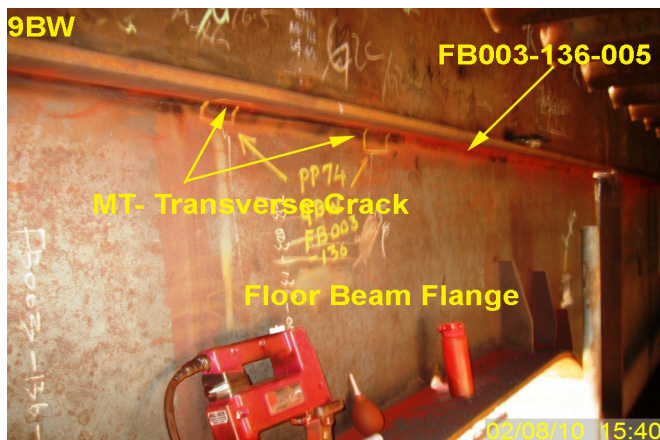
This QA Inspector generated an MT report for this date. The indications are clearly marked on the material near the weld for future repair. The members are identified as OBG Segment 9BW. The weld designations reviewed are as follows:

Description of Incident: During random Quality Assurance Visual review of welds located on segment 9BW, this Quality Assurance Inspector (QA) discovered five (5) Transverse linear indications measuring approximately 6 to 12mm in lengths. The indications were discovered visually and confirmed by Magnetic particle Testing (MT) by Caltrans QA. ZPMC Quality Control MT Technicians claimed that magnetic particle testing have been performed on these welds that require 25% MT. The indication is clearly marked on the material near the weld. The welds are identified as FB003-136-005. The panel point is identified as a PP74. This weld is a Fillet weld joining the Floor beam Web to Flange. The Floor Beam Flange weld is identified as Non SPCM. For further information, please see the attached pictures
